**Lower Butte Creek - Sutter Bypass  
Weir No. 2 Fish Passage Project**

**Preliminary Engineering  
Technical Report**

**December 2003**

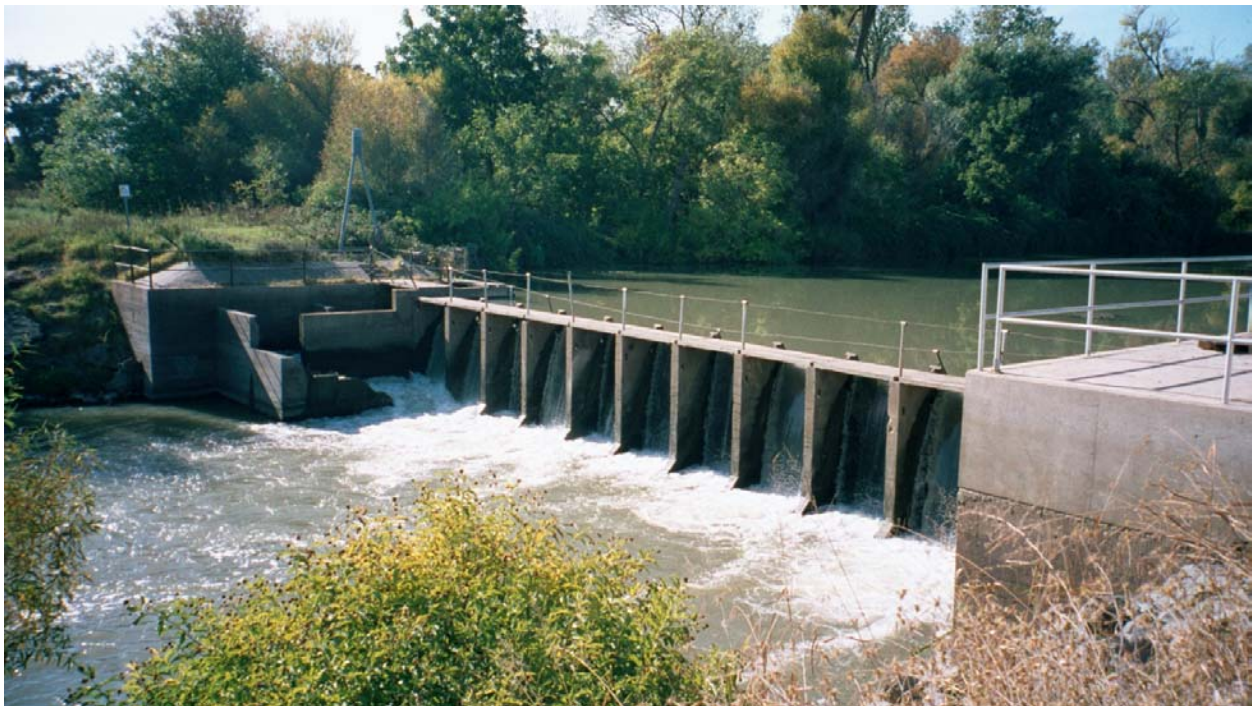
The Weir No. 2 structure has been in place for more than 50 years and likely rests on a foundation constructed in 1925. The wear and deterioration that has occurred over the years has taken its toll on the structure to the point that maintaining a normal operating stage upstream for diversions and a fish ladder may not be possible during low flow periods. Excessive leakage for a typical flashboard structure and recently discovered physical defects indicate that Weir No. 2 needs major repairs or rebuilding.

Figure 3. Existing Weir No. 2 (looking upstream)

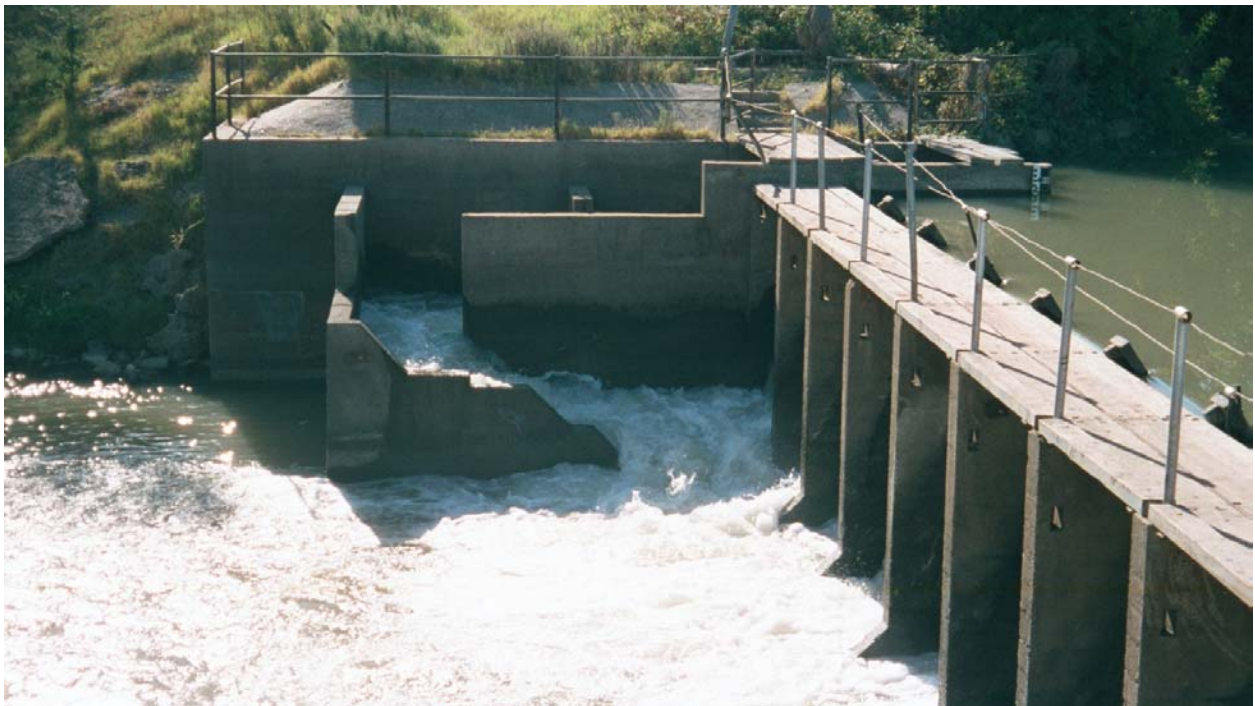
Figure 6. Existing fish ladder entrance

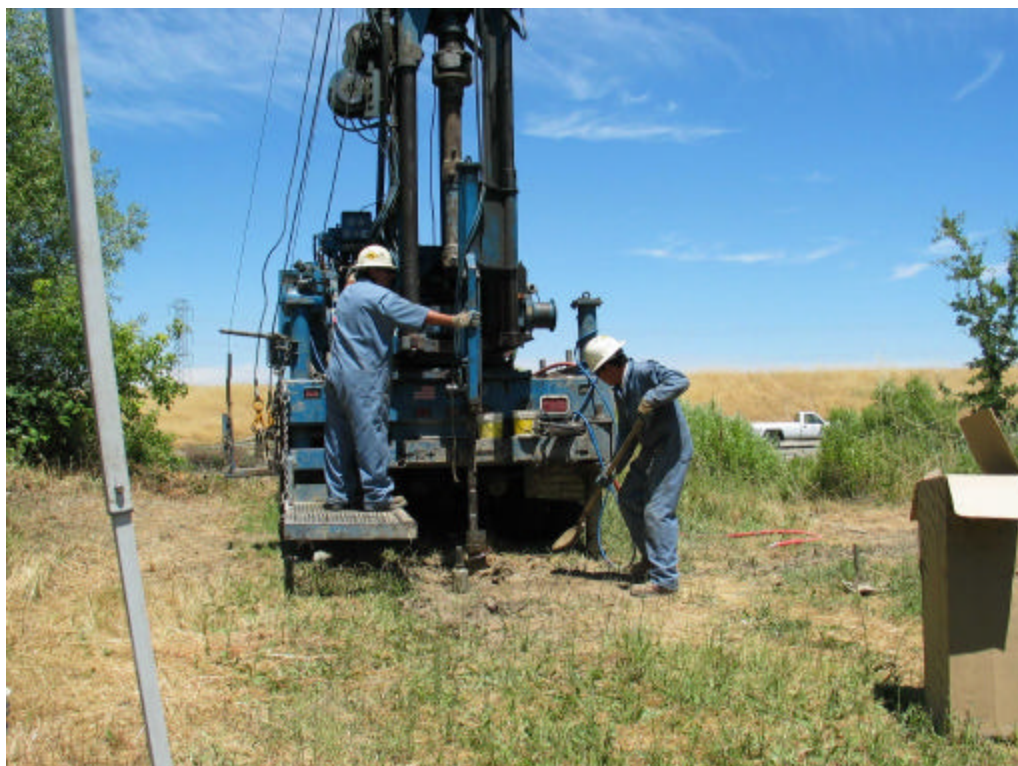
Figure 9. Auger drilling on the west bank of Weir No. 2

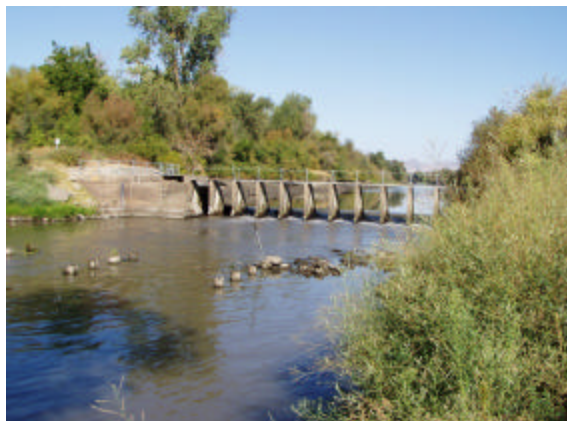
hole became apparent when the survey crew was recording elevations of the apron and discovered a void where the elevation was much lower than the surrounding apron. The hole was estimated to be about 5 to 6 feet deep and 1 to 2 feet in diameter. The finding was reported to DWR SMY staff. This caused concern because the void in the foundation of the existing weir structure is becoming large enough to extend to the piers of the structure which will ultimately result in failure of Weir No. 2.

An evaluation of the structure by the DWR-DOE, Structure Section was requested in August 2002. In September 2002, Weir No. 2 was partially dewatered by DWR SMY staff (Figure 9). This allowed an evaluation to assess the condition of the existing structure (Figure 10). The structural evaluation concluded that significant wear has occurred to the concrete apron of the structure. The concrete apron is worn to the point that three holes exist exposing the underlying soil. A hole exists in the downstream cutoff wall along with an adjacent void, indicating seepage is eroding the soil directly below the apron. Appendix C contains the memorandum summarizing the results of the Weir No. 2 structural evaluation.

Figure 10. Weir No. 2 dewatering
